Surface- and Ground-Water Monitoring and Mapping of Selected Features at the Blue Ridge Parkway Mt. Pisgah Campground, Haywood County, North Carolina, 2002

U.S. Geological Survey Open-File Report 2004–1073

By Douglas G. Smith

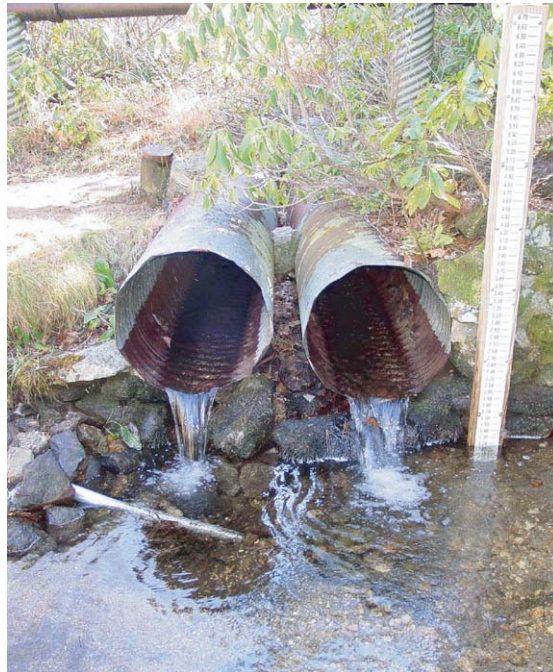
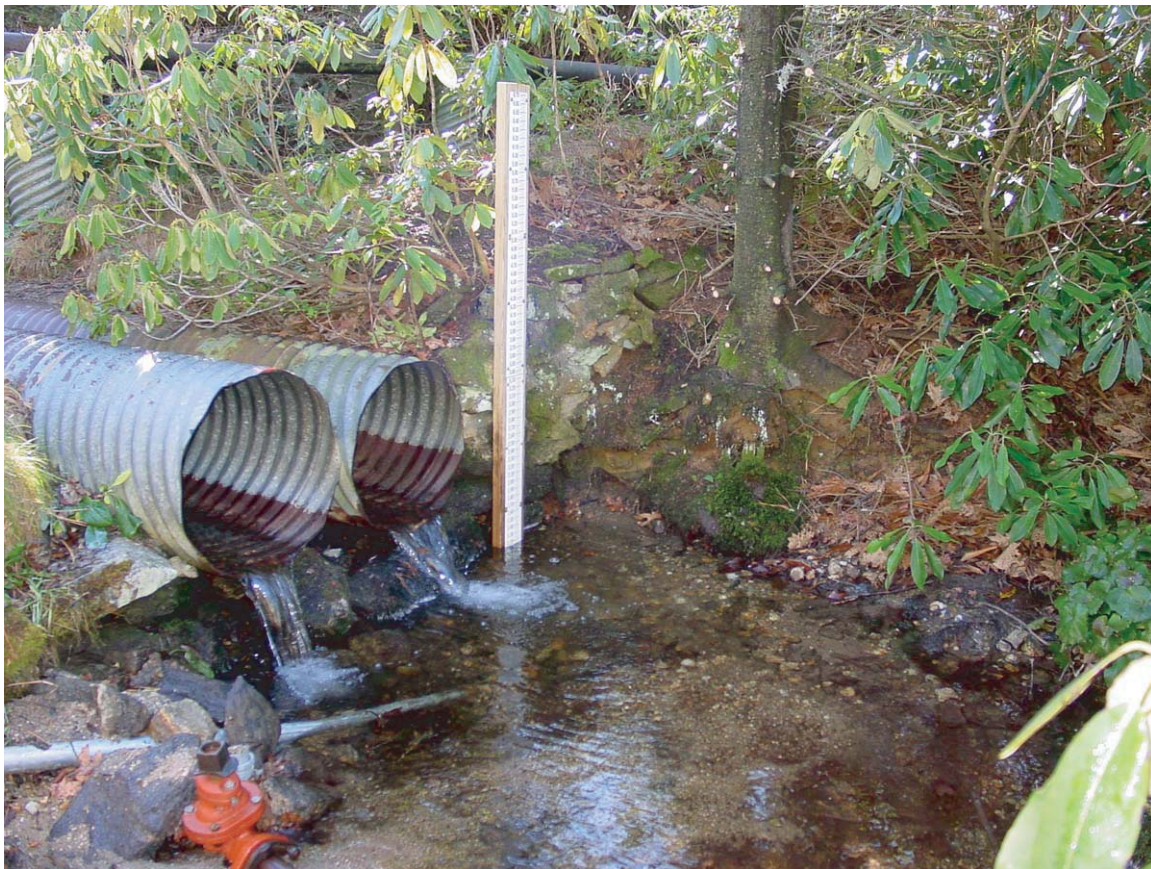
Figure 4. The downstream side of the double corrugated metal pipe (CMP) culvert where the U.S. Geological Survey gaging station was located at the Mt. Pisgah campground.

Water level (stage) and flow (discharge) in the stream draining the campground area were monitored from January 1 to December 31, 2002. An old access road that connects Loops B and C partially impounds surface-water drainage from the natural area (fig. 2). Immediately upstream from the old access road, several small streams converge into a single channel before flowing through two corrugated metal pipe (CMP) culverts that pass beneath the old roadbed (fig. 4). On the downstream side of the culvert, water empties into a small natural pool before flowing into a single, well-defined channel.

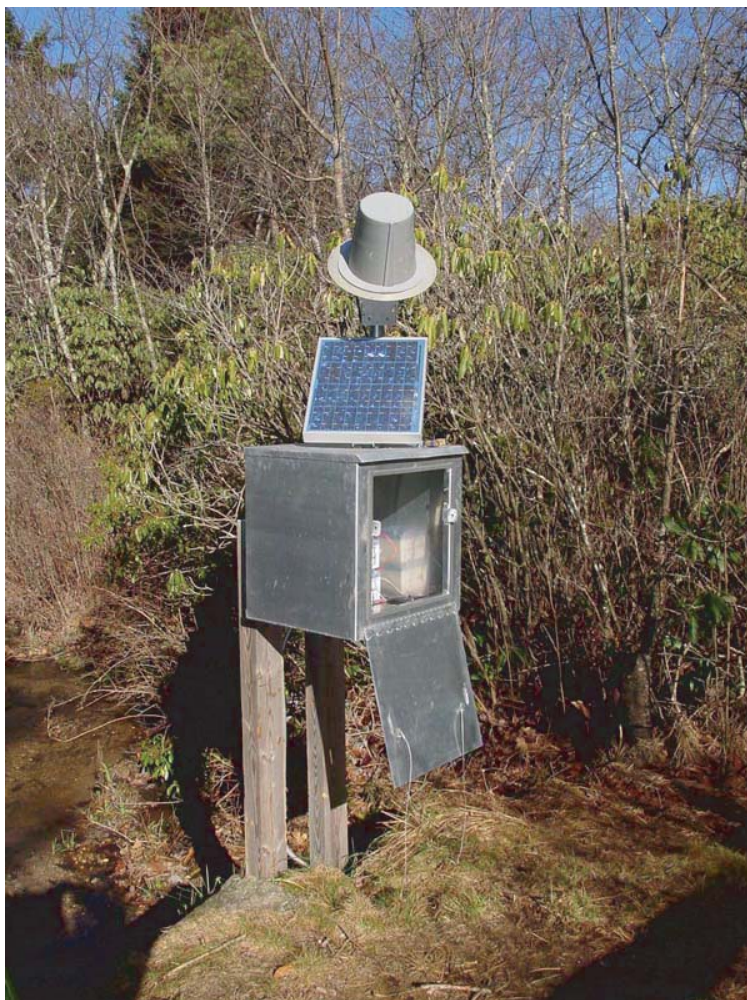
Figure 5. The U.S. Geological Survey gaging station that was built to monitor water levels in the stream flowing from the natural area in the center of the Mt. Pisgah campground.

A USGS streamgaging station was constructed at the downstream side of the culvert (fig. 5) to monitor stage fluctuations in the stream flowing from the natural area in the center of the campground. This stream site was identified as Unnamed Tributary to Pisgah Creek at Flat Laurel Gap, N.C., with USGS station number 0345638607. A steel enamel staff gage was installed in the stream at the downstream side of the culvert. Stage in the stream was monitored by a pressure transducer that was referenced to the staff gage and recorded by instrumentation housed in the gage shelter. Stage data were recorded at 15-minute intervals using an arbitrary gage datum. Recorded stage readings and the staff gage in the stream were set so that a stage of 0.00 ft in gage datum represented a corresponding water-surface elevation of 4,836.97 ft above mean sea level (referenced in this report to National Geodetic Vertical Datum of 1929 [NGVD29]). The mean sea level elevation of gage datum was determined by level surveys based on a nearby North Carolina Geodetic Survey benchmark (PI-1 1994).

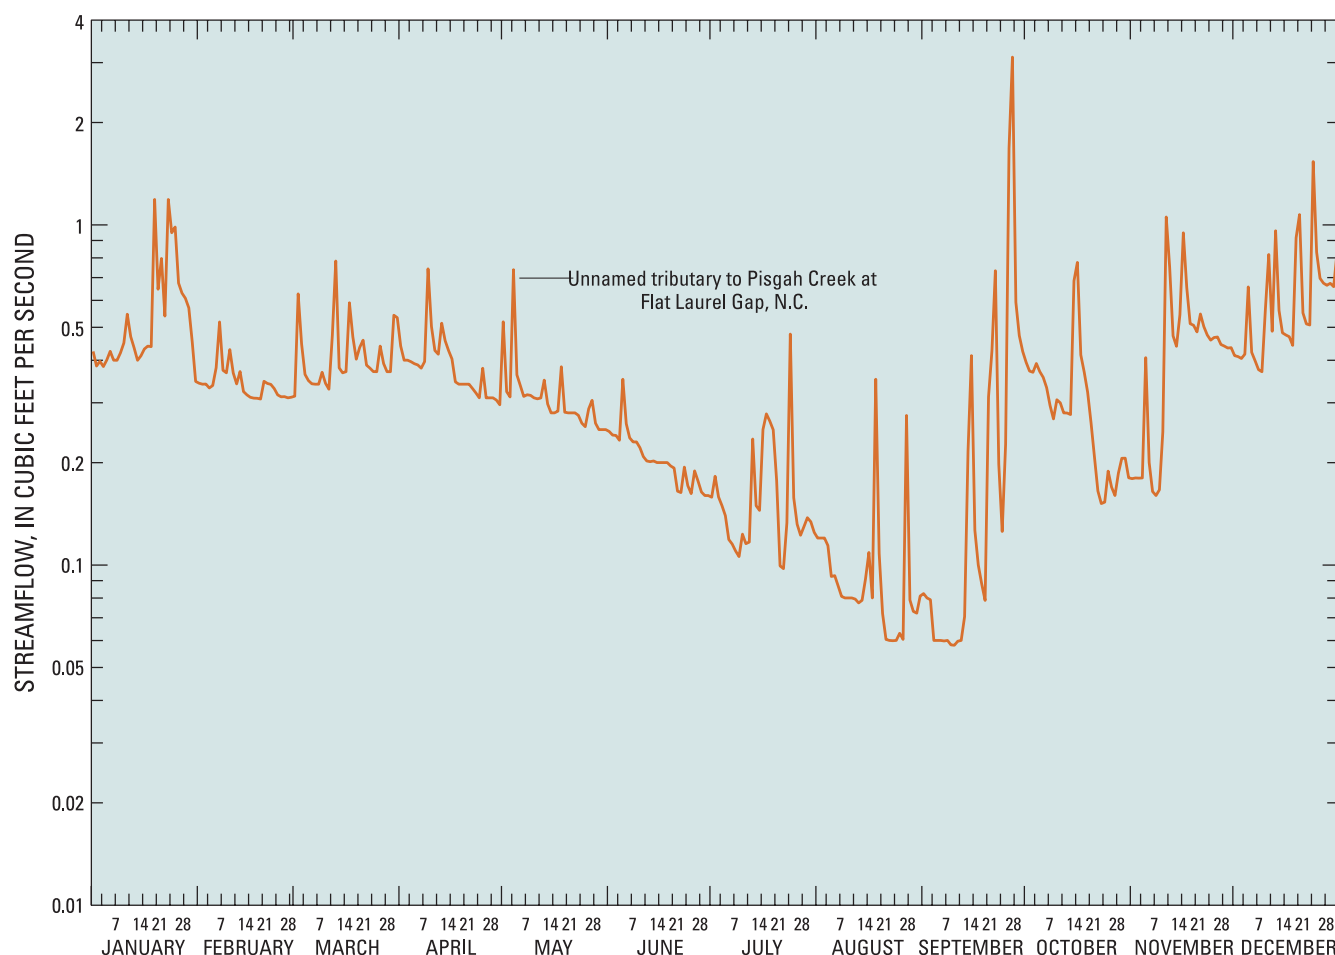
Figure 6. Daily mean streamflow values at unnamed tributary to Pisgah Creek at Flat Laurel Gap at the Mt. Pisgah campground.

Continuously recorded stage in the stream ranged from 1.09 to 1.89 ft above gage datum (4,838.06 to 4,838.86 ft above mean sea level) during the 2002 calendar year. Periodic measurements of streamflow (discharge) ranged in stage from 1.11 to 1.66 ft and in discharge from 0.07 to 4.71 cubic feet per second (ft^3/s). A stage/discharge relation was developed using these streamflow measurements, and corresponding discharge values were calculated for each stage value recorded by the gage. A hydrograph of mean daily discharges for calendar year 2002 is shown in figure 6 as calculated for each day of the period of study (table 1). An additional table containing daily maximum, minimum, and mean discharge values also is presented in the appendix (table A1).

Based on recorded stage data for calendar year 2002, streamflow from the natural area ranged from 0.05 to 9.7 ft^3/s . The annual daily mean flow for the year was approximately 0.35 ft^3/s (about 226,000 gallons per day). The instantaneous peak stage (1.89 ft) and discharge (9.7 ft^3/s) occurred on September 26, 2002, and the instantaneous minimum flow (0.05 ft^3/s) occurred on August 23 and September 7, 9, 10, and 11, 2002. The highest monthly mean flow occurred during December 2002, and the lowest monthly mean flow occurred during August 2002.

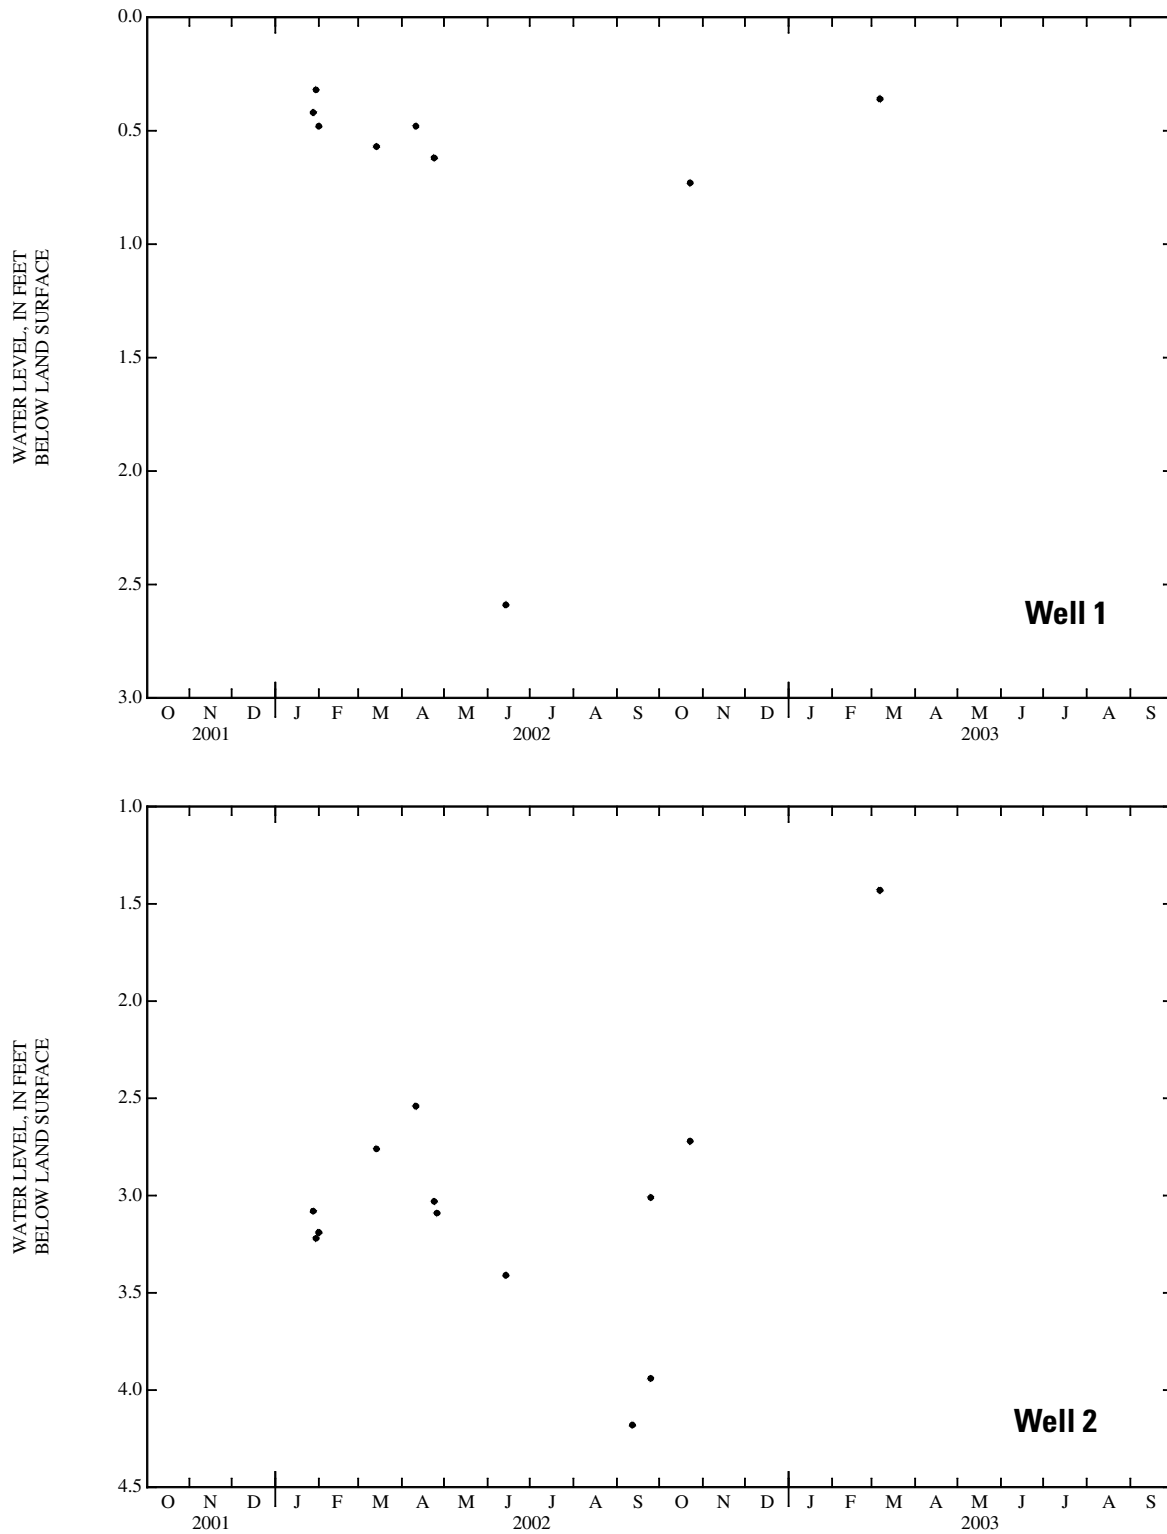
Figure 7. Periodic water levels measured in shallow wells 1 and 2 at the Mt. Pisgah campground, Haywood County, North Carolina.

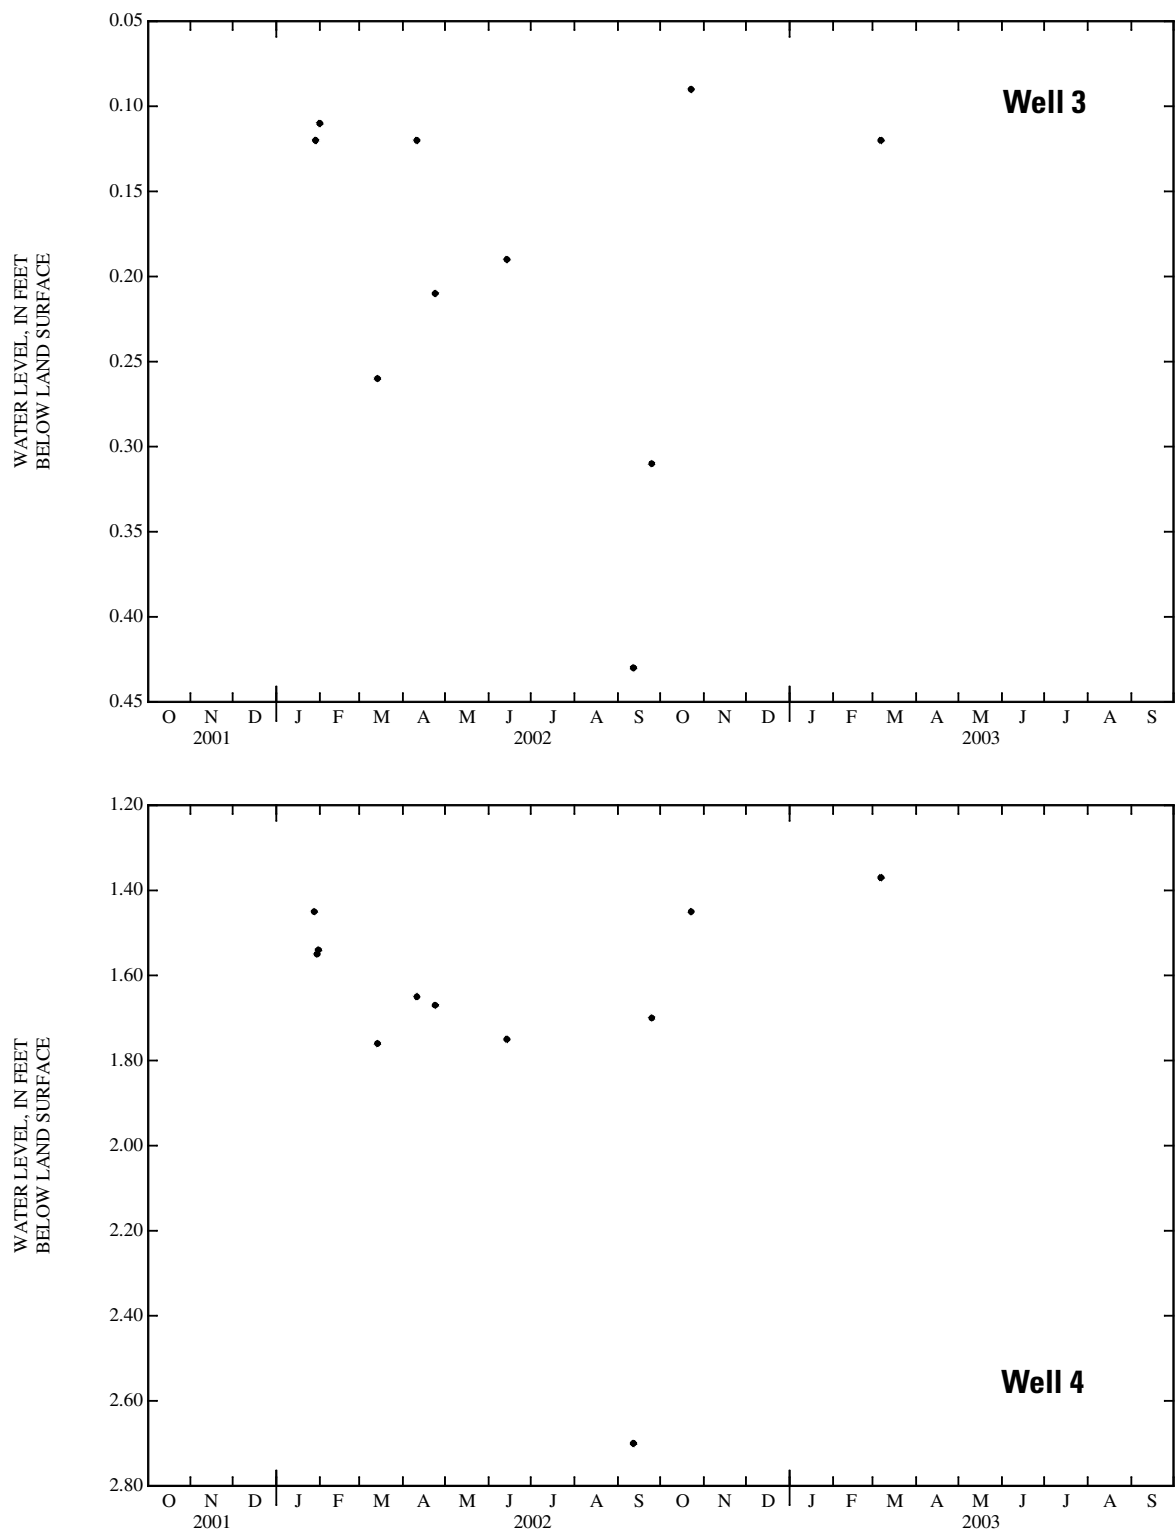
Figure 8. Periodic water levels measured in shallow wells 3 and 4 at the Mt. Pisgah campground, Haywood County, North Carolina.

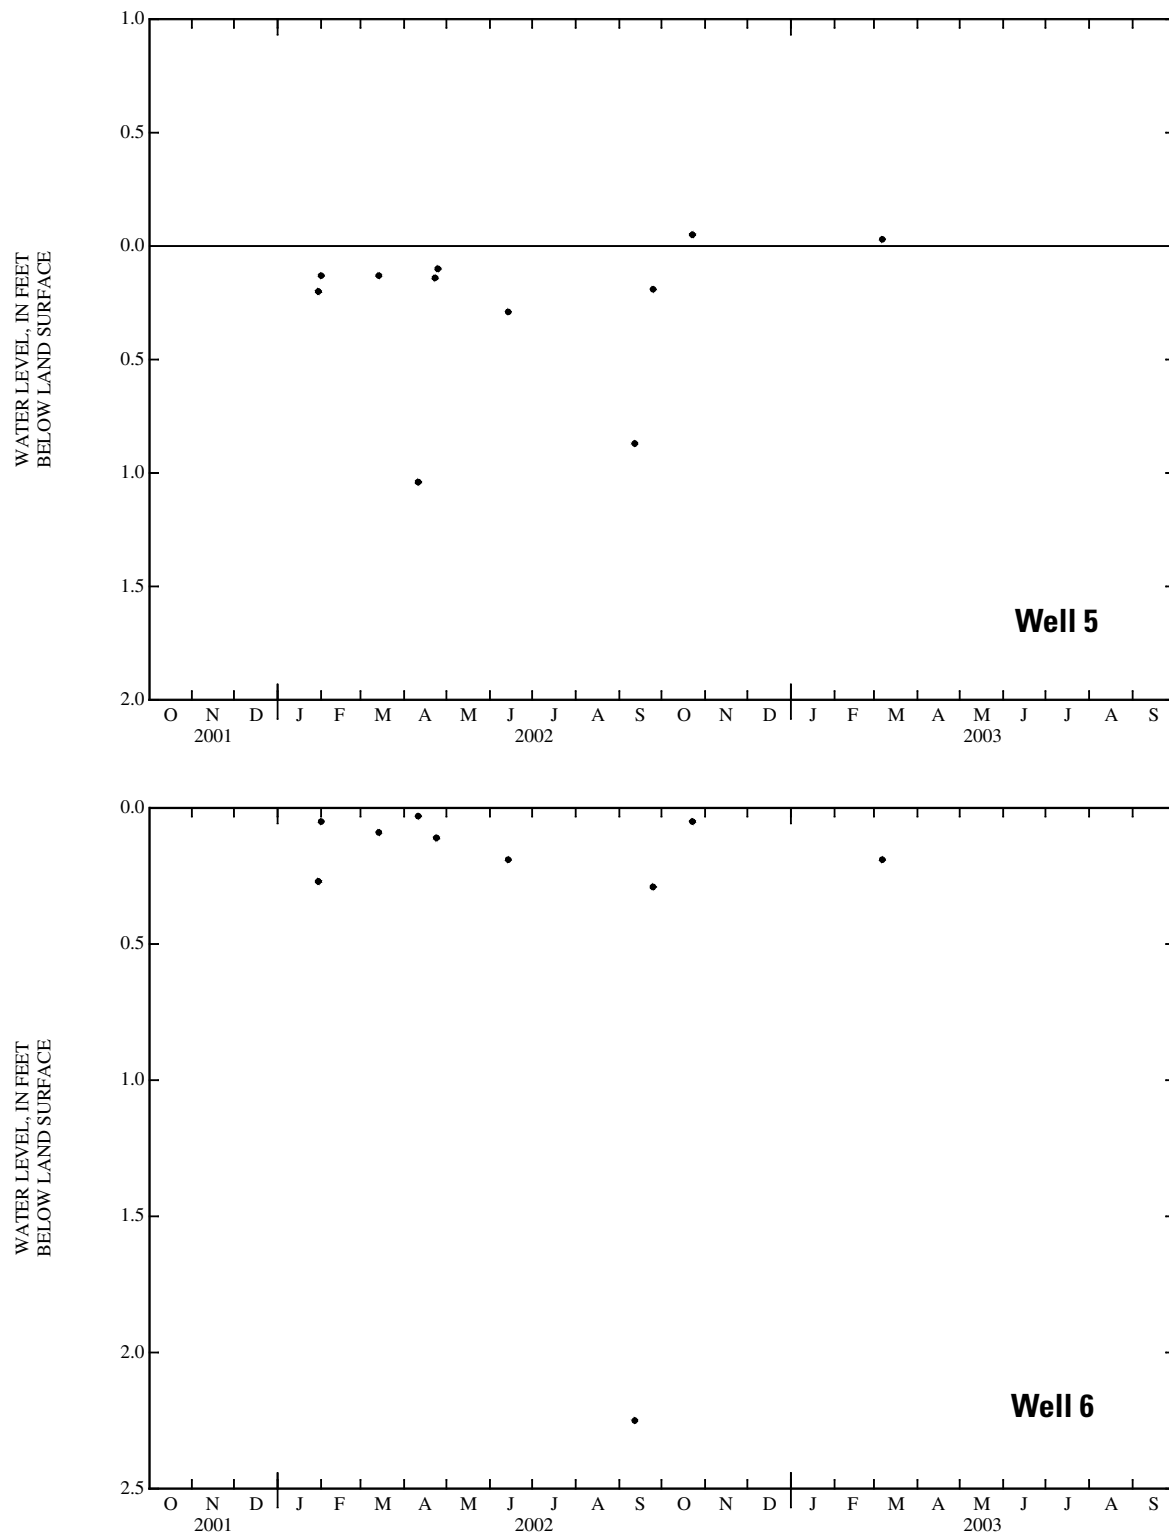
Figure 9. Periodic water levels measured in shallow wells 5 and 6 at the Mt. Pisgah campground, Haywood County, North Carolina.

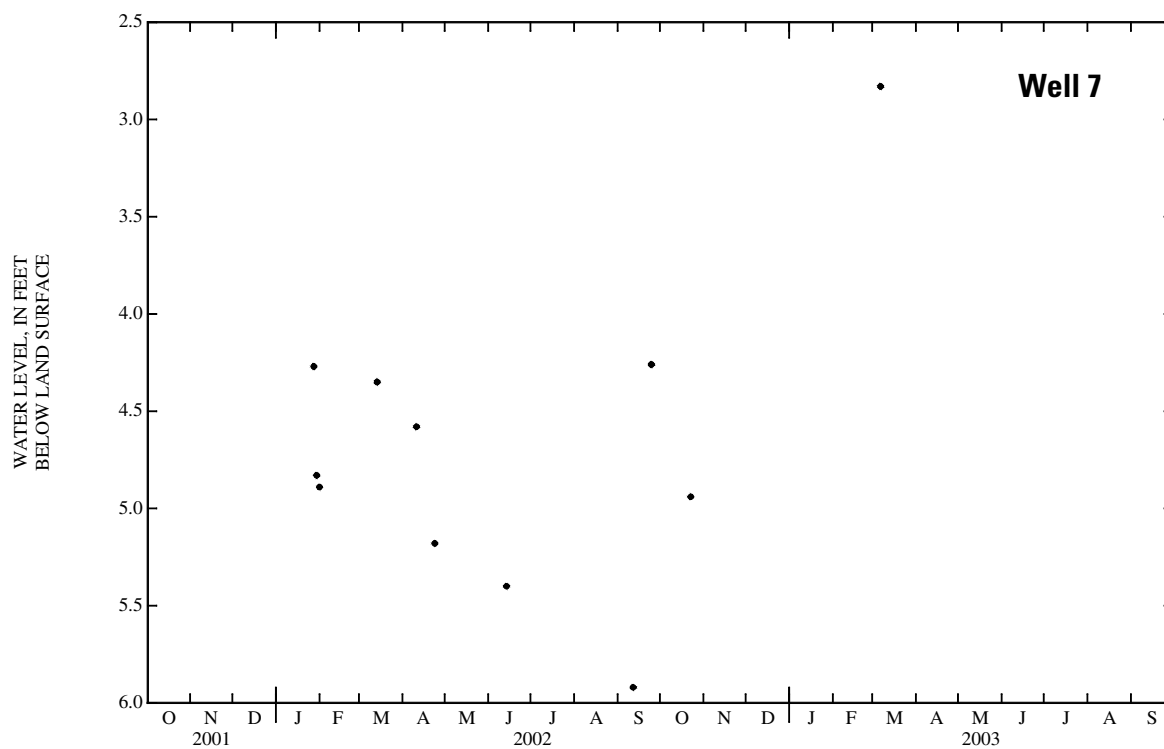
Figure 10. Periodic water levels measured in shallow well 7 at the Mt. Pisgah campground, Haywood County, North Carolina.

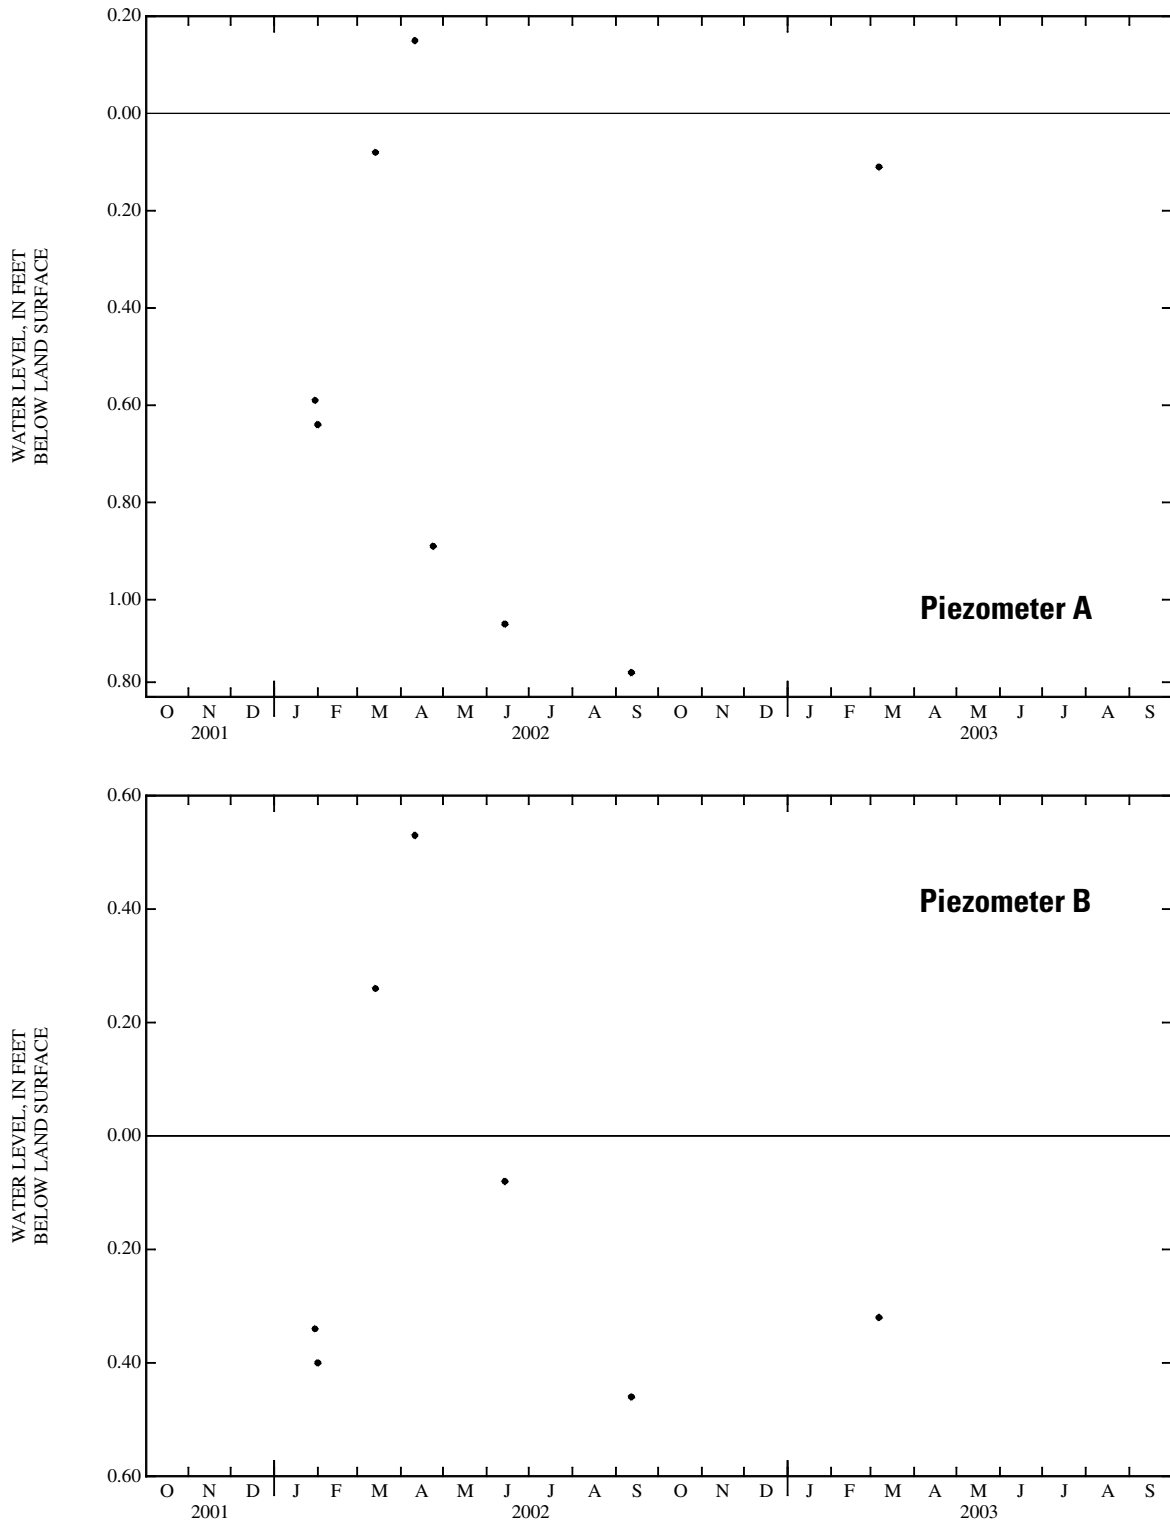
Figure 11. Periodic water levels measured in piezometers A and B at the Mt. Pisgah campground, Haywood County, North Carolina.
